Forensic engineering in geotechnics, the Dutch approach on CPT interpretation

E. de Jong*¹

¹ *Geobest B.V., Mijdrecht, The Netherlands*

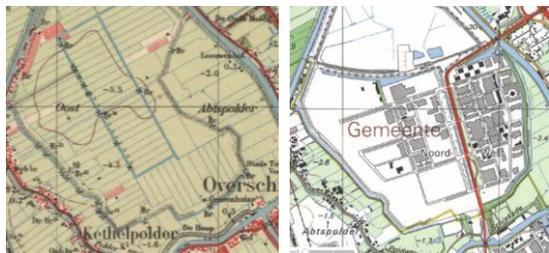
Figure 5. The original polder (left 1939) and the industrial area (right 1995); source www.watwaswaar.nl.

If the engineer had been able to consult the internet he would have found figure 5, showing the original polder with a groundlevel of NAP -5,5 m, the modified city maps from the period 1960 to 1980 and the actual heights (grounlevels) from www.ahn.nl that are presented in figure 6.

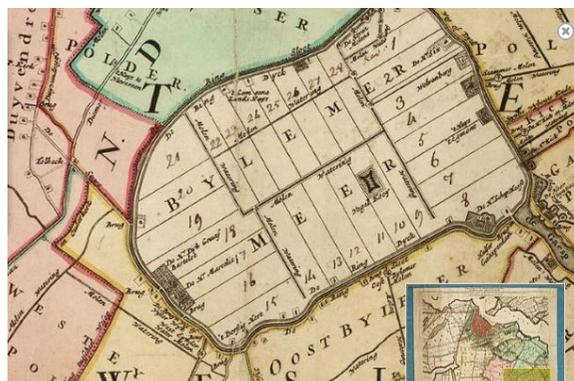
Figure 7. Polder Bijlmermeer 1650; source www.watwaswaar.nl.

In chapter 2.2 the geological history of this site was already discussed. However, the irregularities in the CPT's did not end with these geological phenomena. The polder “Bijlmermeer” was created in 1627 and the oldest available map of the polder dates back to 1650.

In the 1960's the urban area of Amsterdam expanded to this area and highway A9 was opened in 1982, more or less on the exact location of the former Bijlmer Ringsloot, the canal that surrounded the polder.

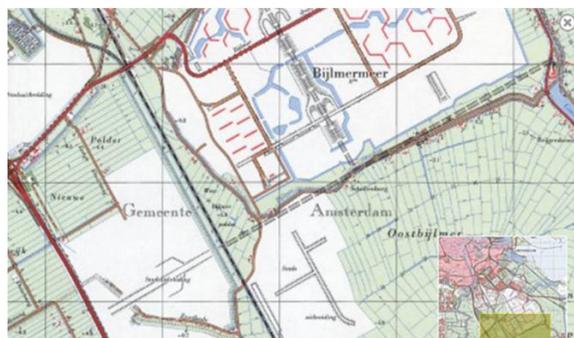
Figure 8. Polder Bijlmermeer 1969. The dotted line represents the A9 highway; source www.watwaswaar.nl.
